Nesting Use of Bridges by the Northern Rough-winged Swallow in the Sacramento Area

Daniel A. Airola, Airola Environmental Consulting, 2700 6th Ave., Sacramento, CA 95818.

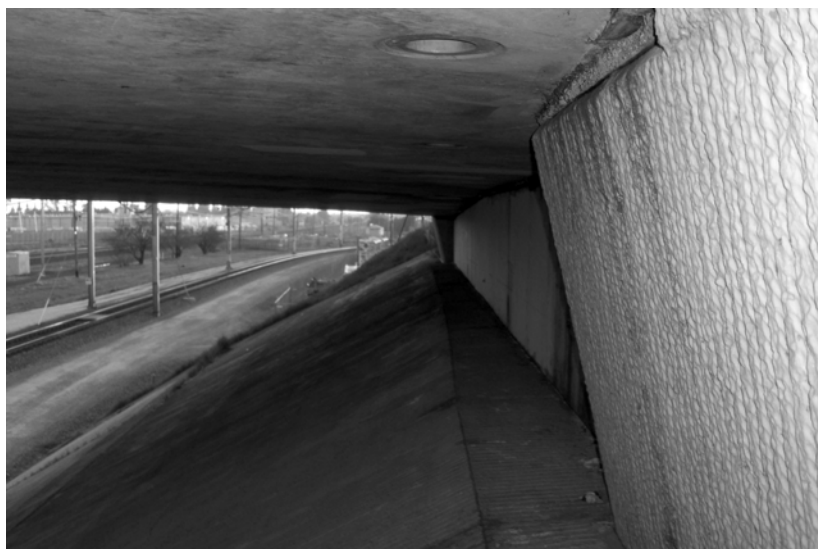
Figure 1. Sloped abutment at west side of the Arden Way overpass of railroad tracks in Sacramento, California. Note weep-hole entrances to bridge nesting chambers in upper foreground. Weep holes here are 0.8 m (2.3 ft) away from the 1.6 m (5 ft) tall vertical abutment wall. One of these holes adjacent to the abutment wall was used in three different years by Northern Rough-winged Swallows.

As a result of observed use patterns (see Results), we focused attention on use and characteristics of holes near bridge abutments (i.e., ends of bridge spans; Figure 1). We refer to holes immediately adjacent to abutments as “abutment holes” and holes in the main portion of bridges as “main span holes”. Most abutments are diagonally shaped except for a

short (1-2 m; 3-6 ft) vertical wall at the far upper end (“sloped abutments”), Figure 1). A few of the surveyed sites, generally at shorter overpasses, had “vertical abutments”, in which the bridge ends in a full-length vertical wall.

Of a total of 40 holes observed used by Northern Rough-winged Swallows (presumably mostly as nest sites), 18 (45%) were within abutment holes located near sloped bridge abutments (Figure 1), 2 (5%) were at vertical abutments, and 20 (50%) were in main span holes. The pattern of swallow use among sites with and without nesting Purple Martins differed substantially. At martin colonies, 18 (60%) of 30 holes used by swallows were located near abutments, while only 2 (20%) of 10 holes in non-martin sites were near abutments. This pattern of hole use at martin and non-martin sites differed significantly ($\chi^2_{1.d.f.} = 4.80; p < 0.05$).
